FINAL REPORT  
MAY 1995

REPORT NO. 94-26

ENHANCED WOOD PALLET  
EVALUATION

VALIDATION ENGINEERING DIVISION  
SAVANNA, ILLINOIS 61074-9639

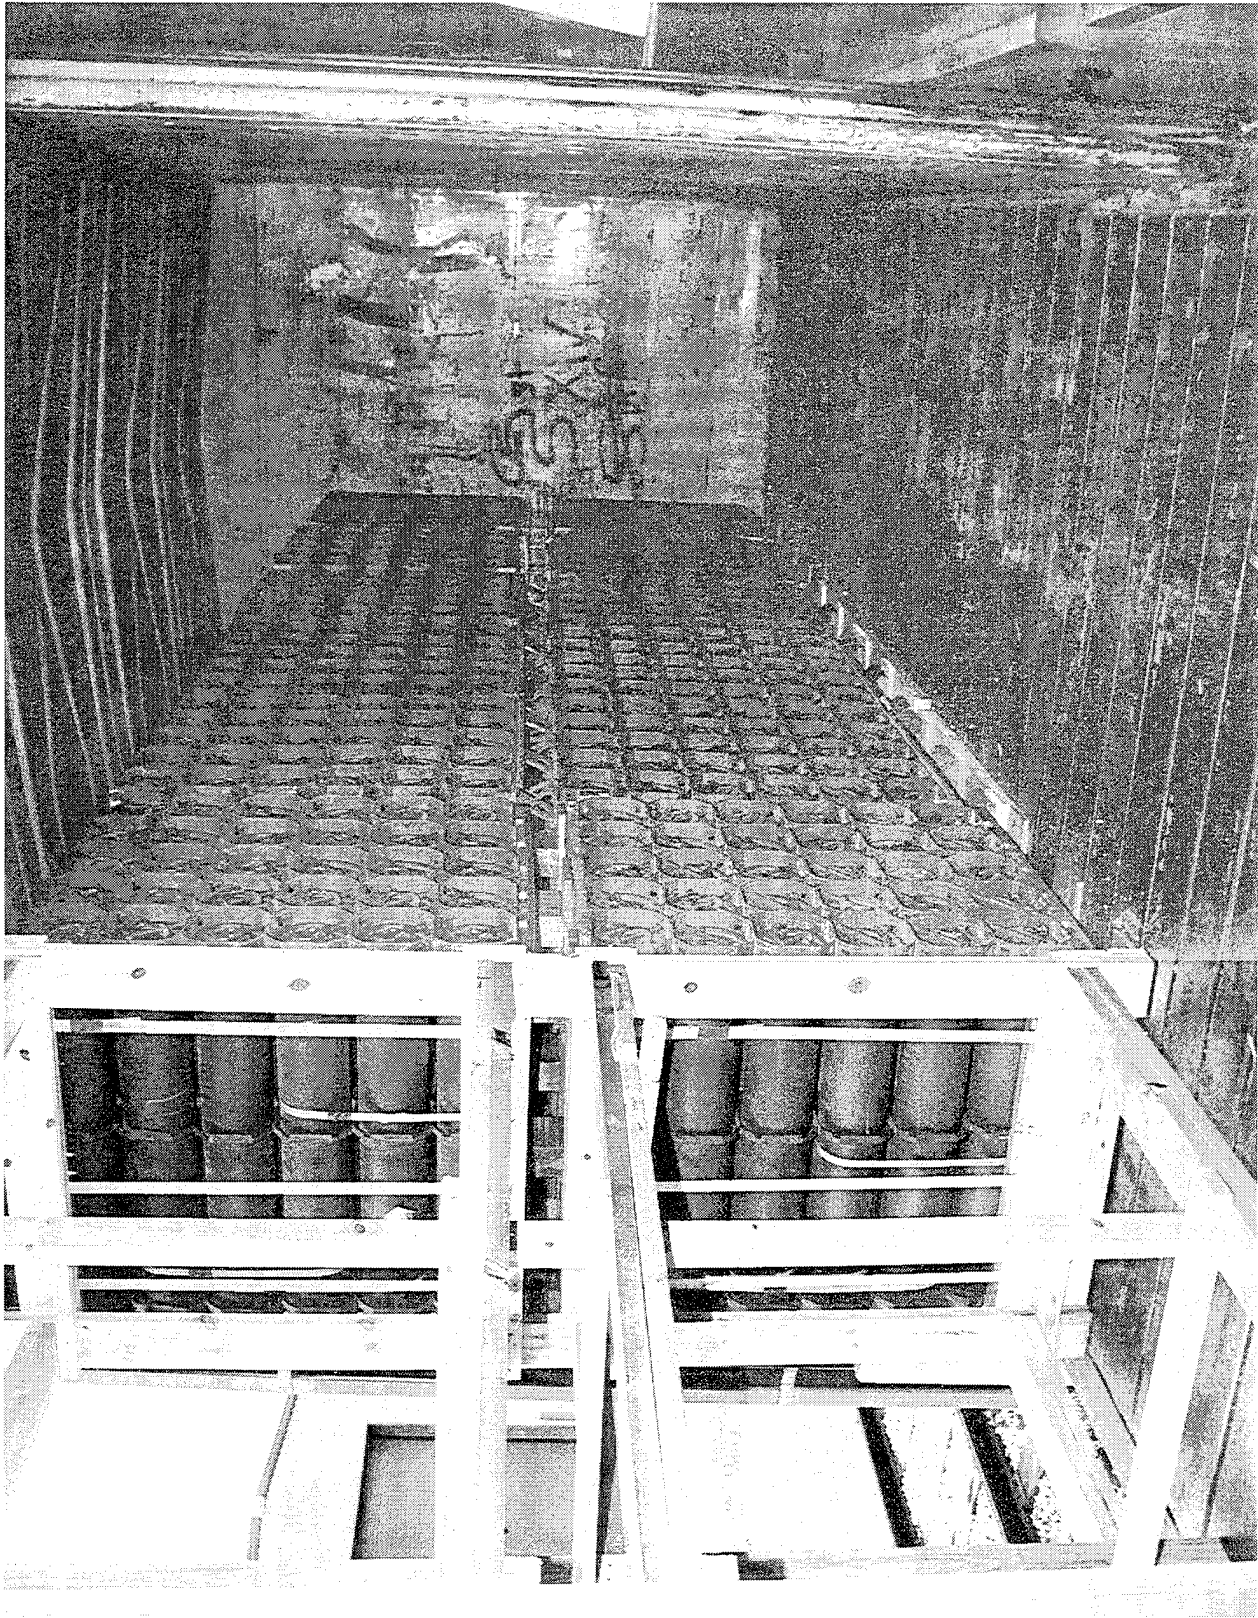
U.S. ARMY DEFENSE AMMUNITION CENTER AND SCHOOL - SAVANNA, IL	
PHOTO NO. SCN94-222-4168. This photo shows an overall view of the 120MM ammunition pallet loaded in the boxcar prior to testing.
